**Bulletin No.11 – Updated August 2025**

### **ColorCote® Plus (Chemical Resistant) Paint Range & Colours**

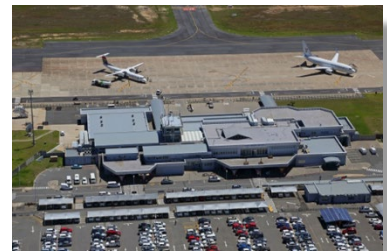
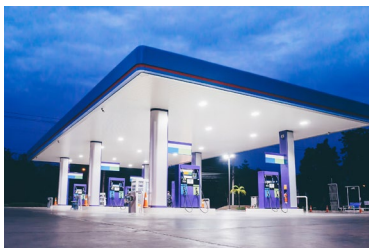
**Airports** – All commercial airports are exposed to aviation fuel dumps which usually occur on the roofs of the buildings within the flight paths – a case-by-case approach is typically taken when recommendations are given to determine the risk & proximity of the roofs/cladding to these flight paths.

**Fuel Stations** – Petrol & Diesel fumes typically rise and end up accumulating on the underside of the canopy of the fuel stations. Long term exposure of such a nature can negatively affect the long-term durability of standard paint coatings.

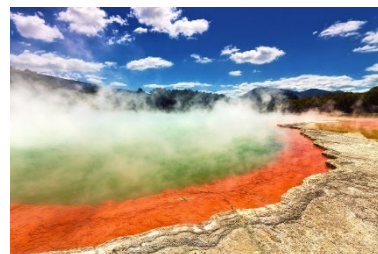
**Certain Geothermal environments** – These environments usually carry a high concentration of airborne sulphur vapours & could impact the long term durability & performance of standard paint coatings on our substrates – A case by case approach is taken to determine the most suitable substrate (ZinaCore®, MagnaFlow® or AlumiGard®) in conjunction with the Plus paint coating & whether double sided is required or not based on risk. If the environment is not deemed suitable for any of our substrates, it will not be warranted.

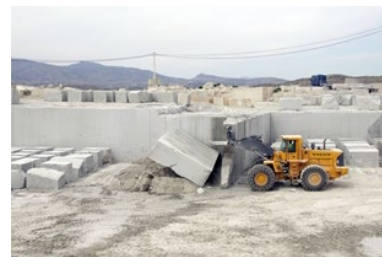
### Environments where ColorCote® Plus paint will not be considered – Quarries

**Concrete** – Fresh concrete & the surrounding dust vapours has a very high alkalinity (pH around 12–13) which can degrade the ColorCote® paint systems & end up exposing the bare steel over time causing eventual perforation.

**Limestone** – Limestone is naturally porous and absorbs water, salts, and pollutants. These act as electrolytes, accelerating corrosion when in contact with steel.
